Utah's Nonpoint-Source Water-Quality Newsletter

Focus: Watershed Restoration Successes

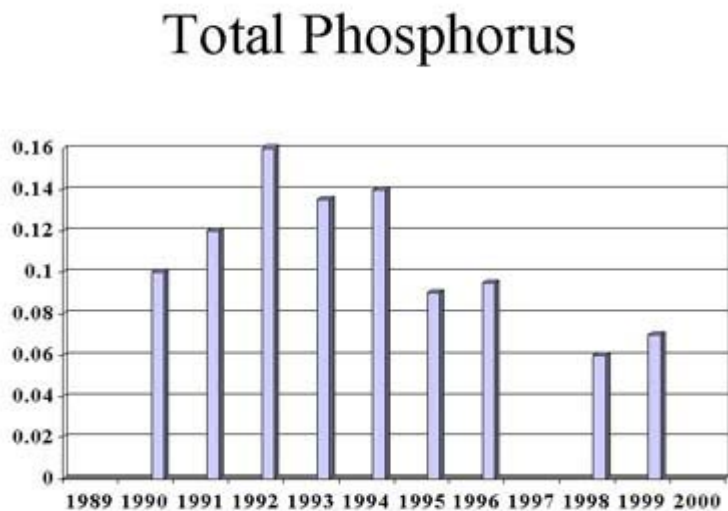
Figure 1

The above chart shows concentration of total phosphorus in the watershed during the 1990s. Data is not available for 1997.

Currently, six years after the initial watershed restoration efforts, we are seeing a measurable improvement in water quality. There is a downward trend of total phosphorus concentration in the watershed (Figure 1). As more animal waste management systems and BMPs are

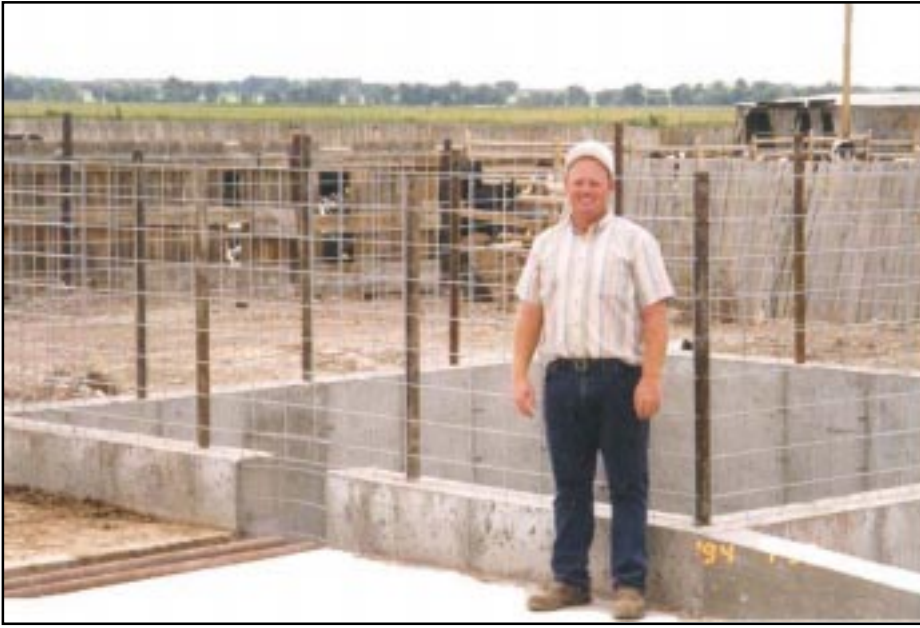
Don Roberts stands on the site of his new animal manure handling facility in 1994. During the years that have followed, the Roberts family has worked through glitches and growing pains until their system works well and runs efficiently today.

The nearly 600 head of Holstein cows at the Roberts dairy were among the first to be managed for water quality in the watershed. The Roberts installed an animal manure management system that separates

manure into liquid and solids. Solids are dry-applied to fields and liquids are pumped from a pond onto adjacent alfalfa fields and other croplands.

Now workers hose down concrete corrals. Manure is flushed to a holding area, and solids and liquids are separated.

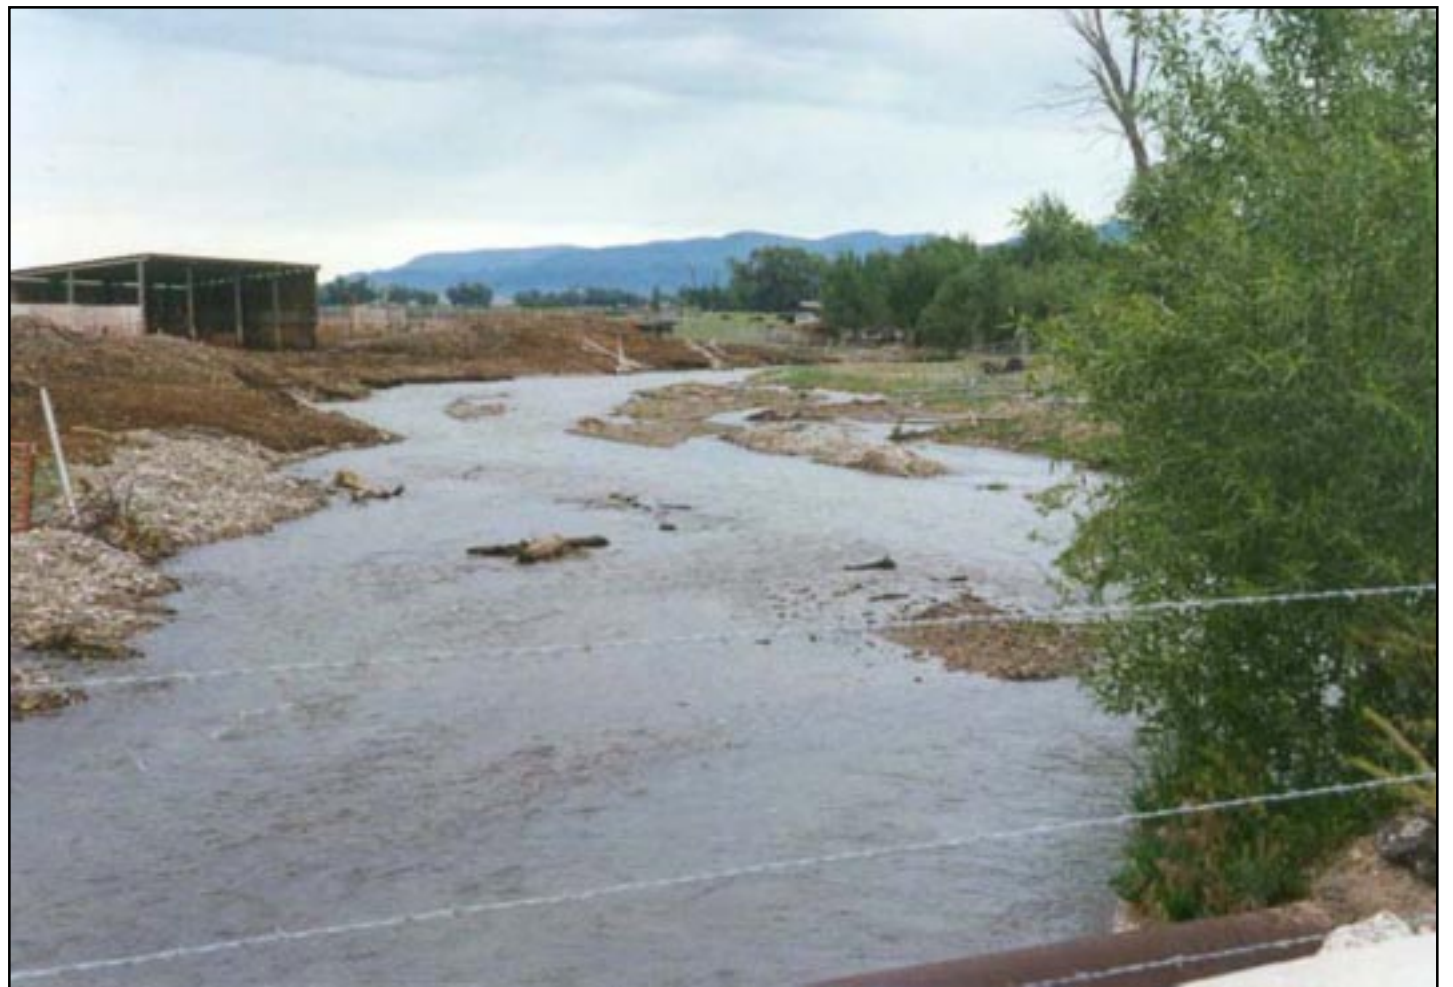
Many sites on the Beaver River still need improvement. In some areas, such as this site, extensive work is required. Other areas will require far less money and effort to fix the pollution problem. Now that the Comprehensive Resource Management plan is nearing completion, Section 319 funding and work should increase steadily over the next few years.

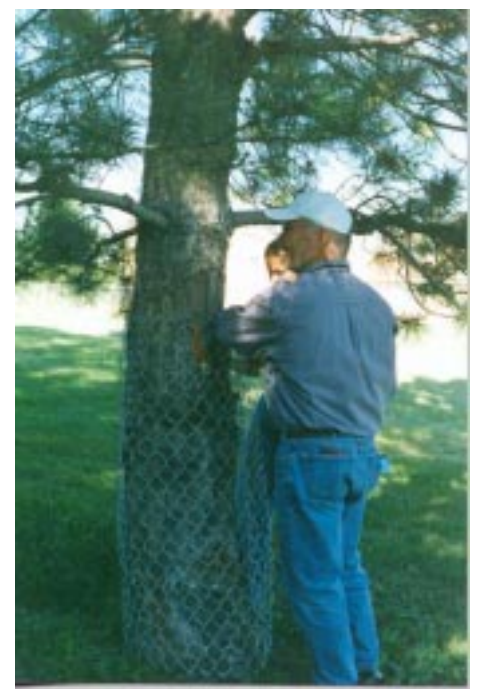
Near the Utah Department of Agriculture and Food building, beaver gnawing on trees is a problem. Following the cleanup, division employees wrapped several trees in chain link fence to protect them from nature's dam builders.
